Manhole Inspection Summary

Manhole # S07YY_001MH

Insp Date: **7/16/07 11:59 AM**

Location Address: **INTERSECTION EDGERTON** Cross Street: **CALLAWAY AVE**

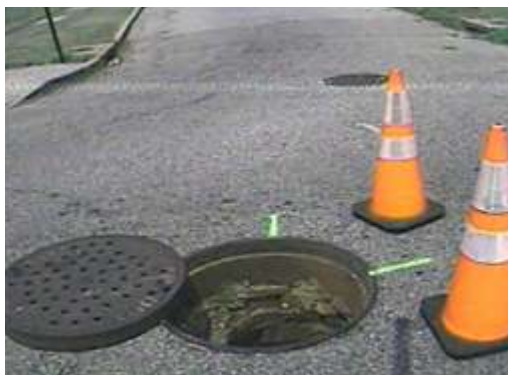
Location View

STORM WATER COVER

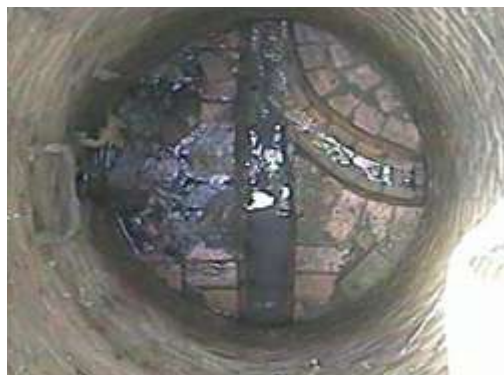
Top View

DEBRIS ON BENCH

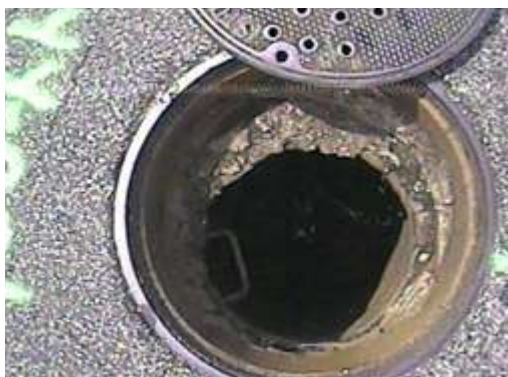
Top View

FRAME AND CHANNEL OFFSET

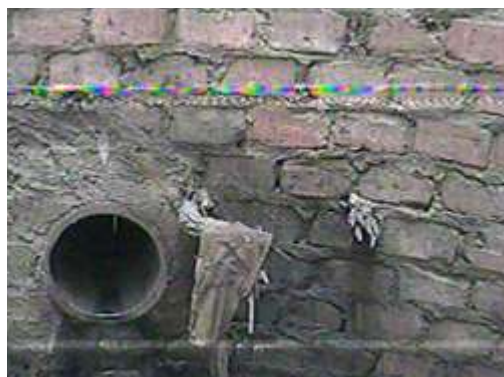
Defect 1

Steps Count: **6** Missing: **2** ☒ **Corroded**

Surcharge ☒ **Evidence Of Surcharge** Depth: **3** (ft.) ☐ Active Surcharge Present

CORRODED RUNG/ EVIDENCE OF SURCHARGE

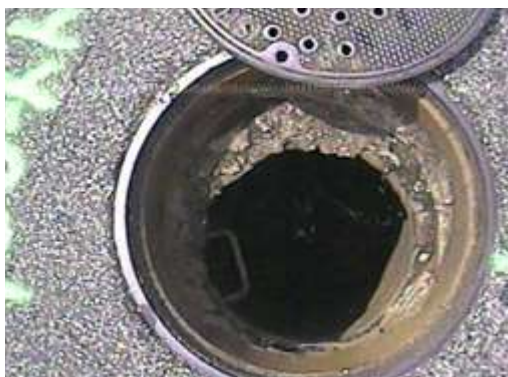
Defect 2

Condition: ☐ Sound ☐ Cracked ☐ Root Intrusion ☒ **Loose Brick** ☐ Deteriorated

LOOSE BRICKS ON FRAME ADJUSTMENT

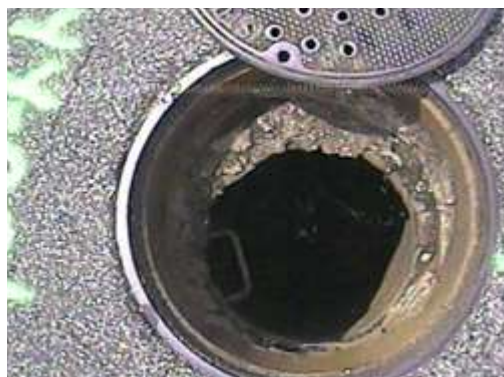
Defect 3

Frame Offset: **7** (in.) Condition: ☒ Sound ☐ Cracked ☐ Leaks

OFFSET FRAME

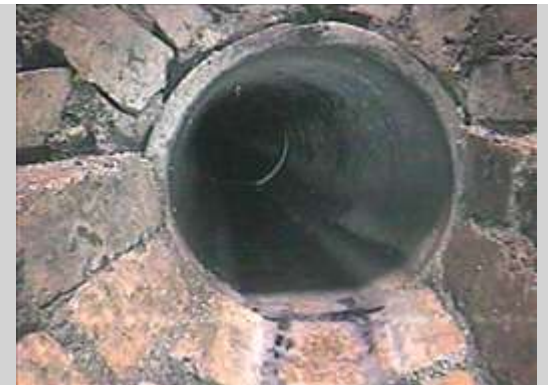
3 O'Clock Inflow

Infiltration: **None** Pipe Seal Cond: **Cracked**
